## THERMALLY BROKEN SYSTEM

UNIGRID™  
WALL SYSTEM

ENG-EXT-0527-2600

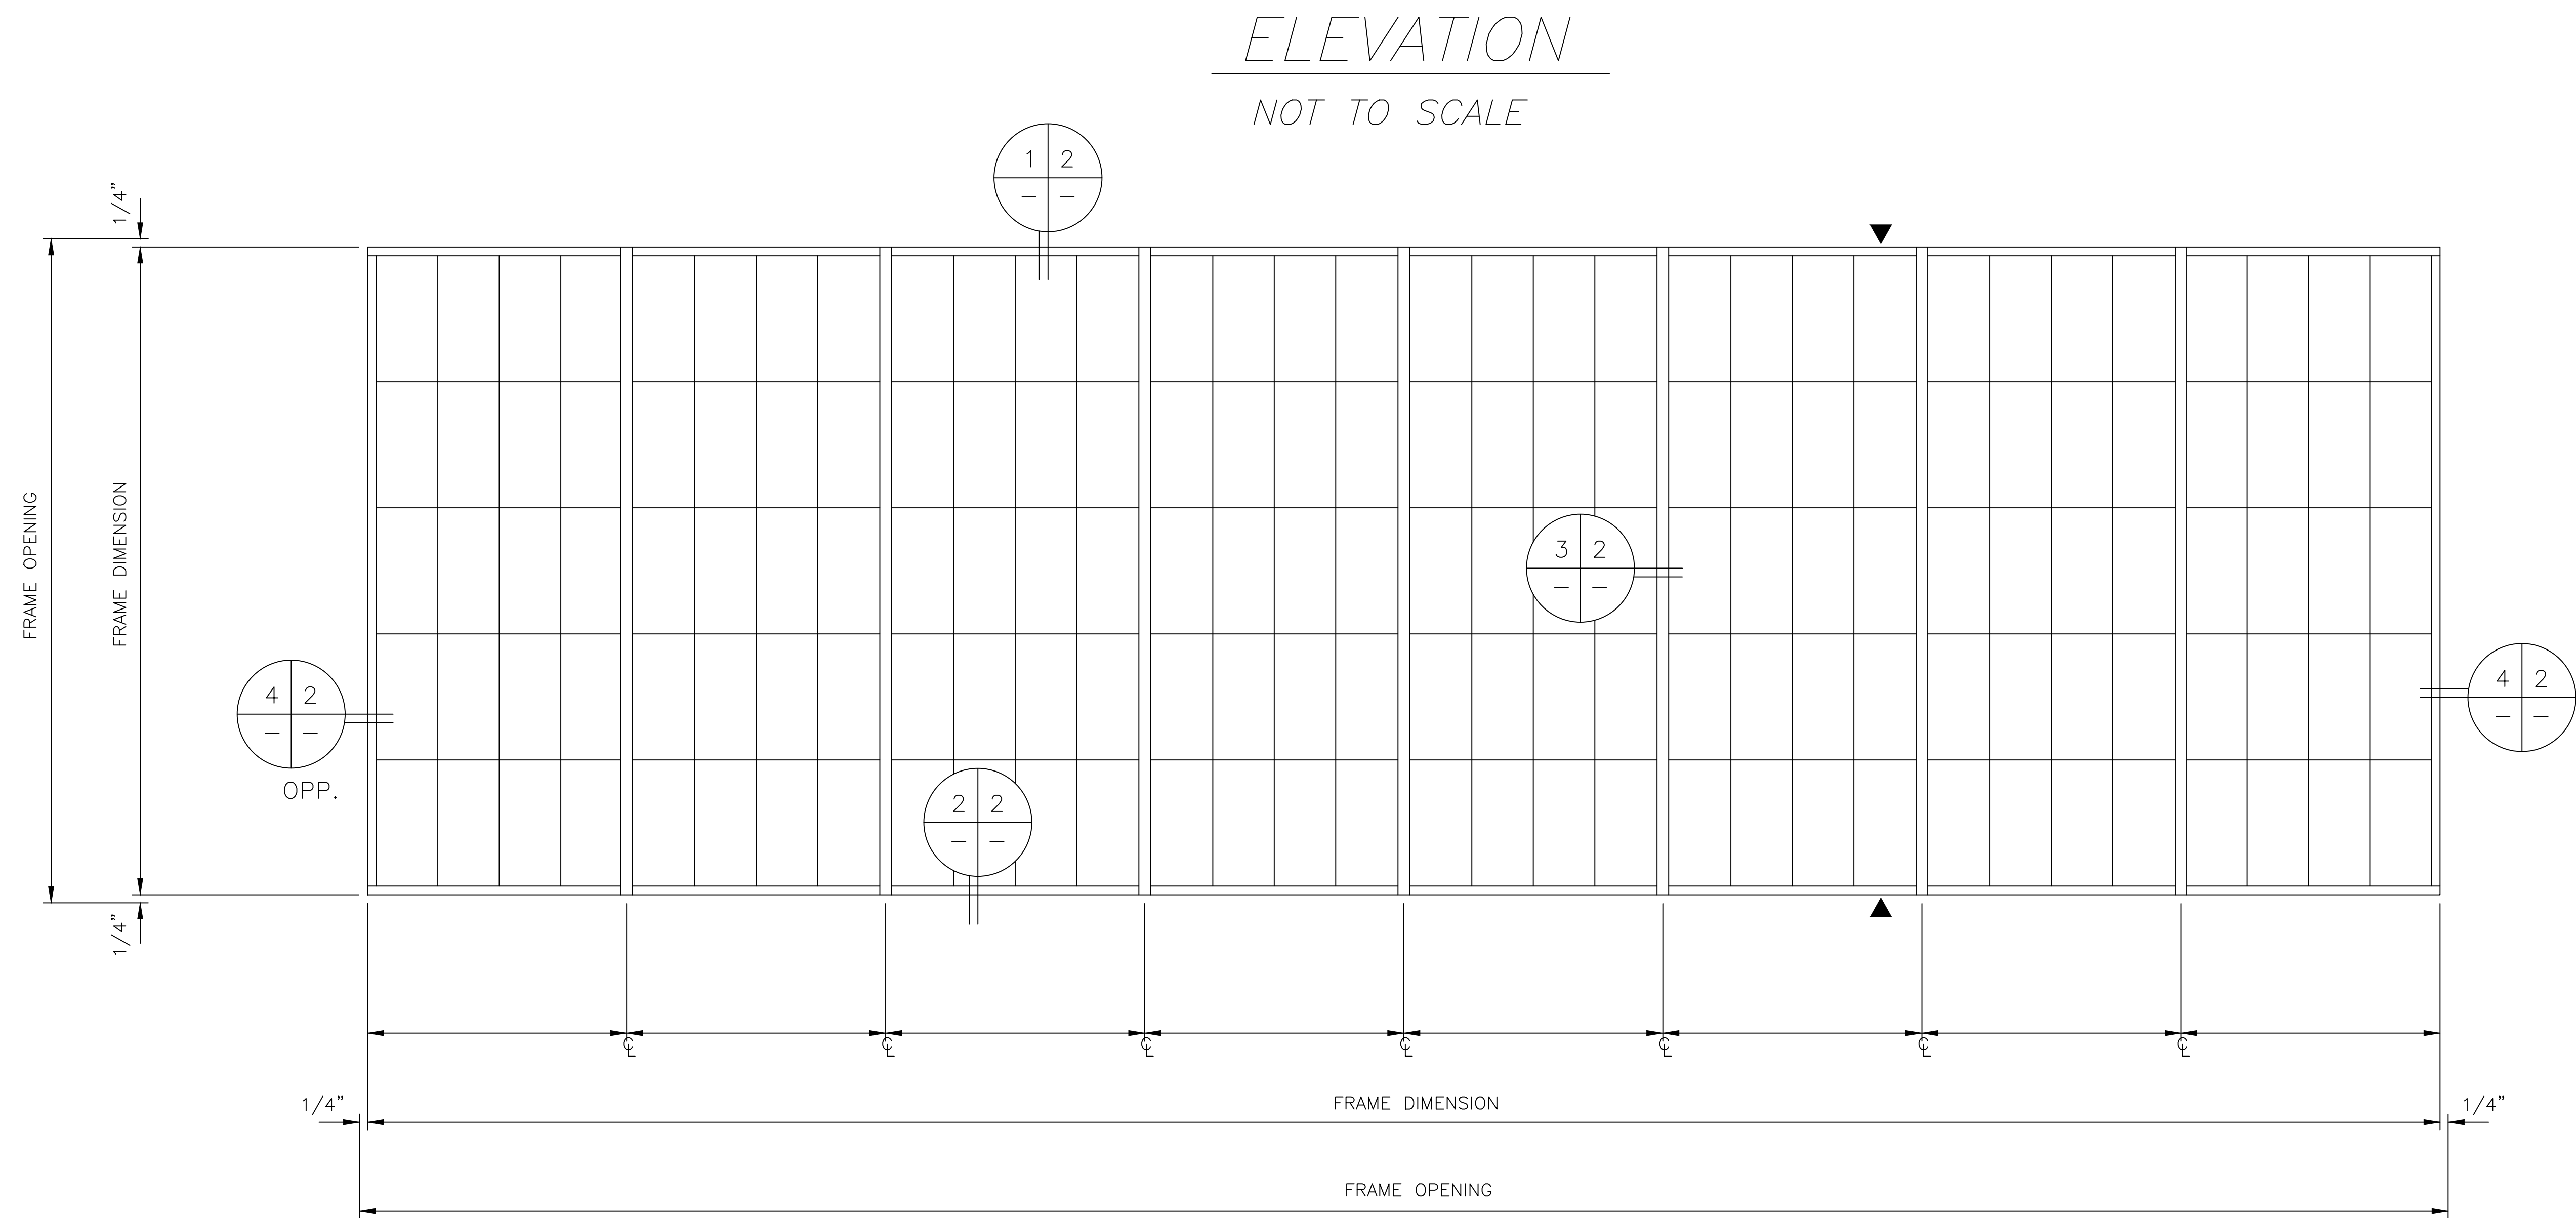
▲ INDICATES 1/4" EXPANSION JOINT (TYP.) (LENGTHS > 24'-0")
