*NON-THERMALLY BROKEN 4" SYSTEM*

UNIGRID™  
WALL SYSTEM

Fenestration

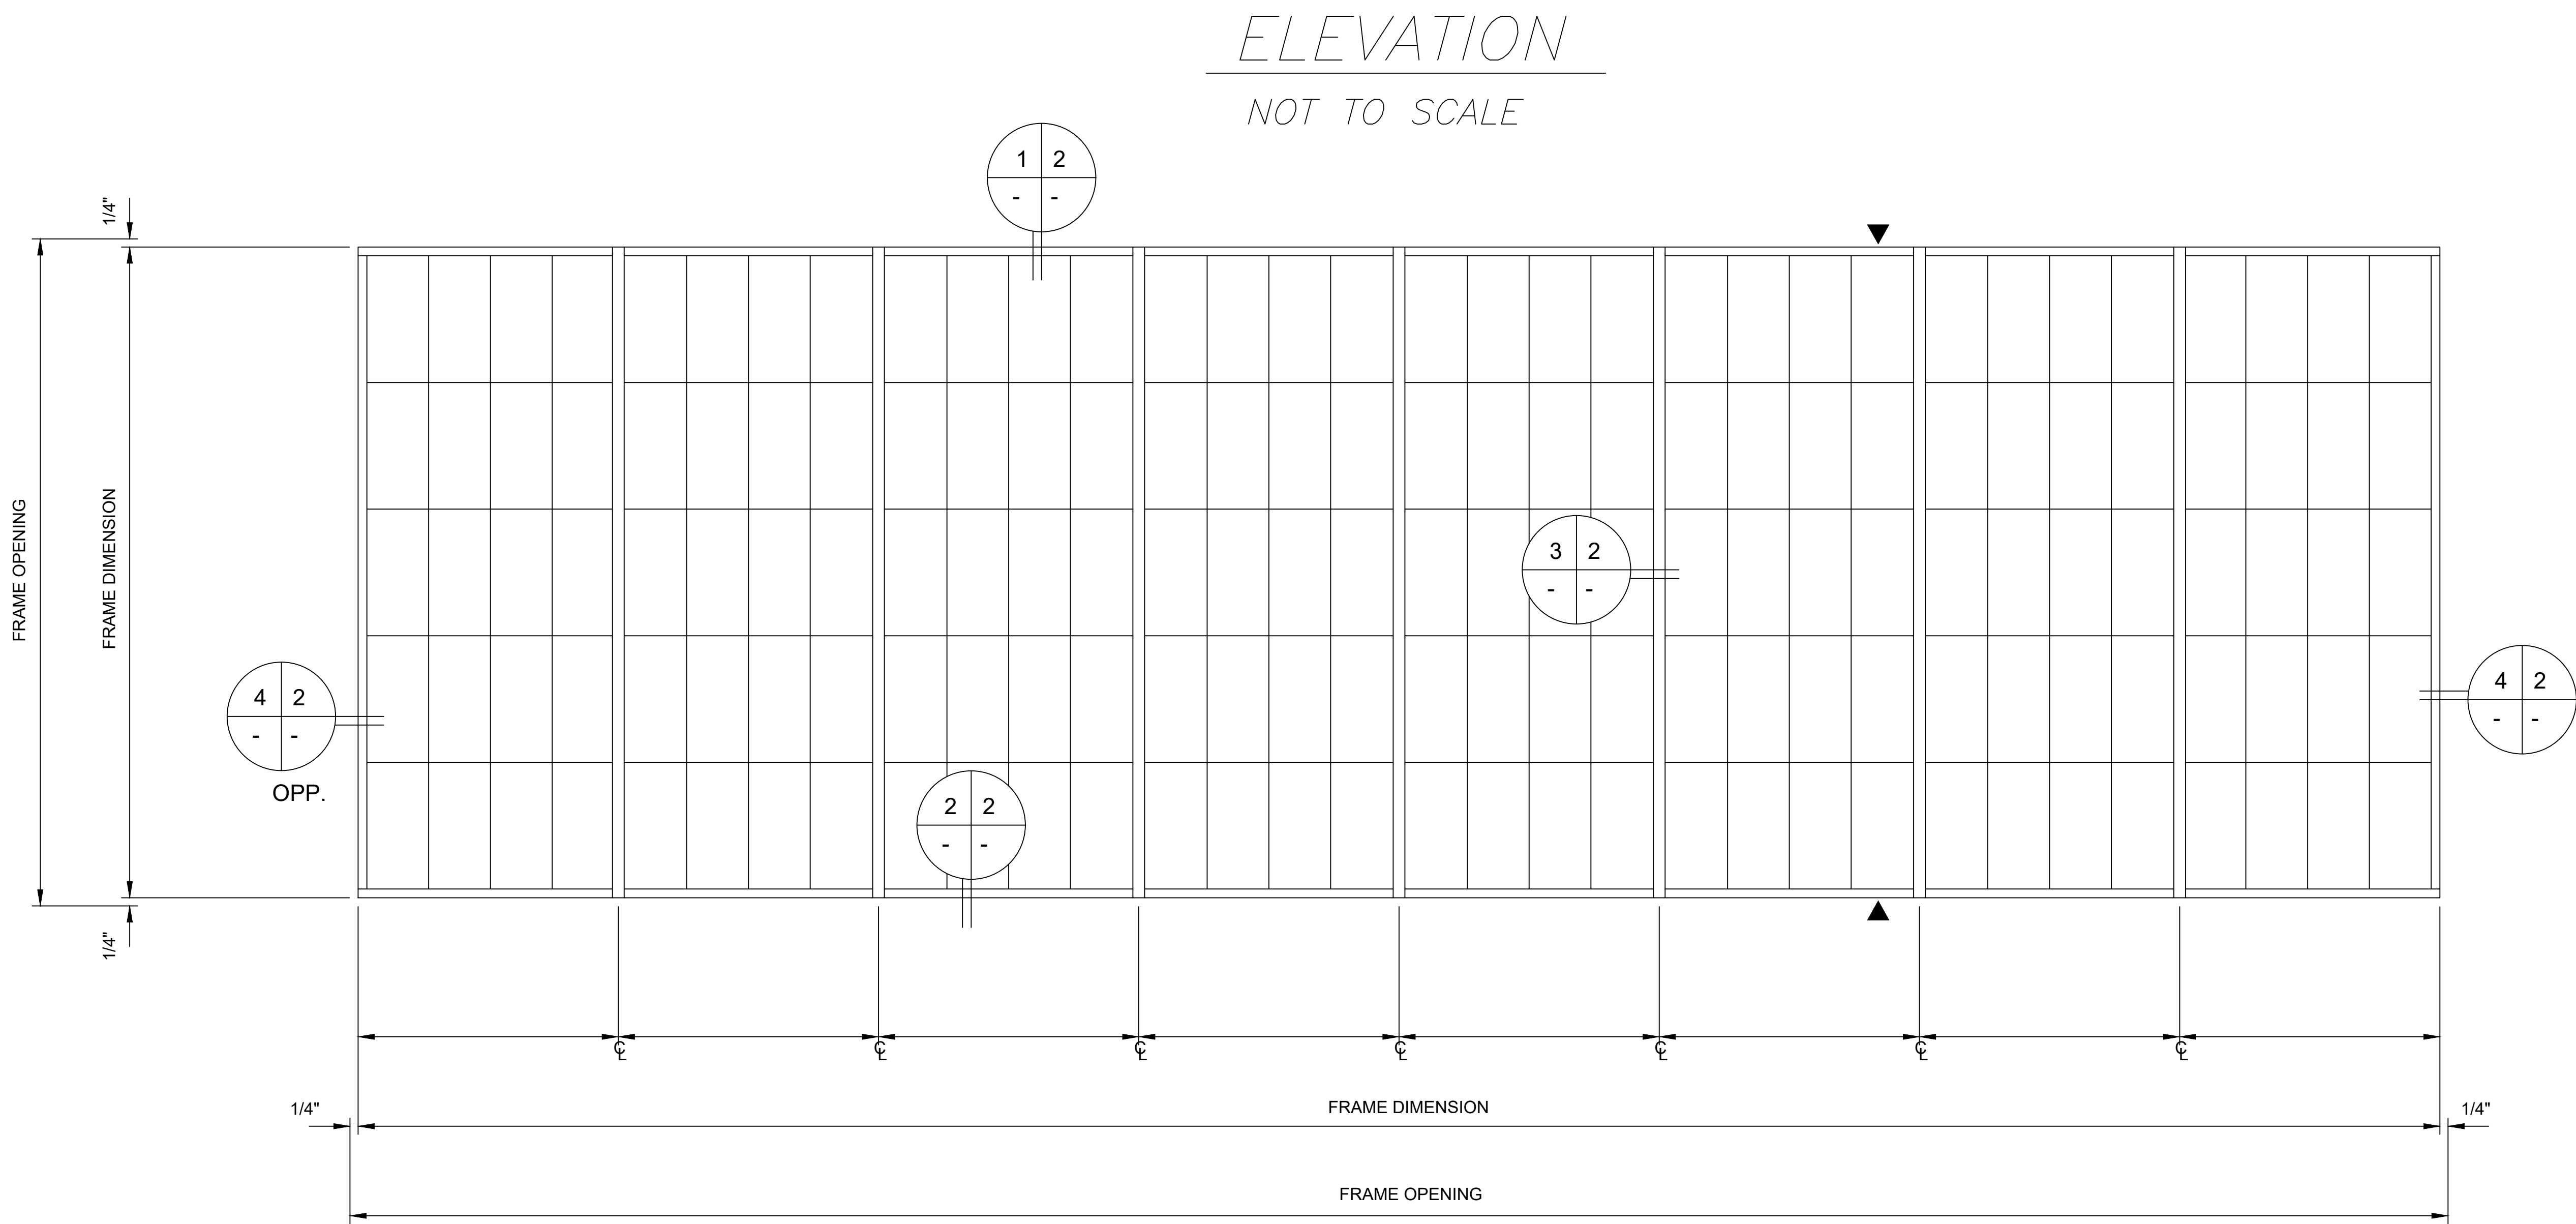
SHEET NO.  
1 OF 2

▲ INDICATES 1/4"  
EXPANSION JOINT (TYP.)  
(LENGTHS 24'-0")

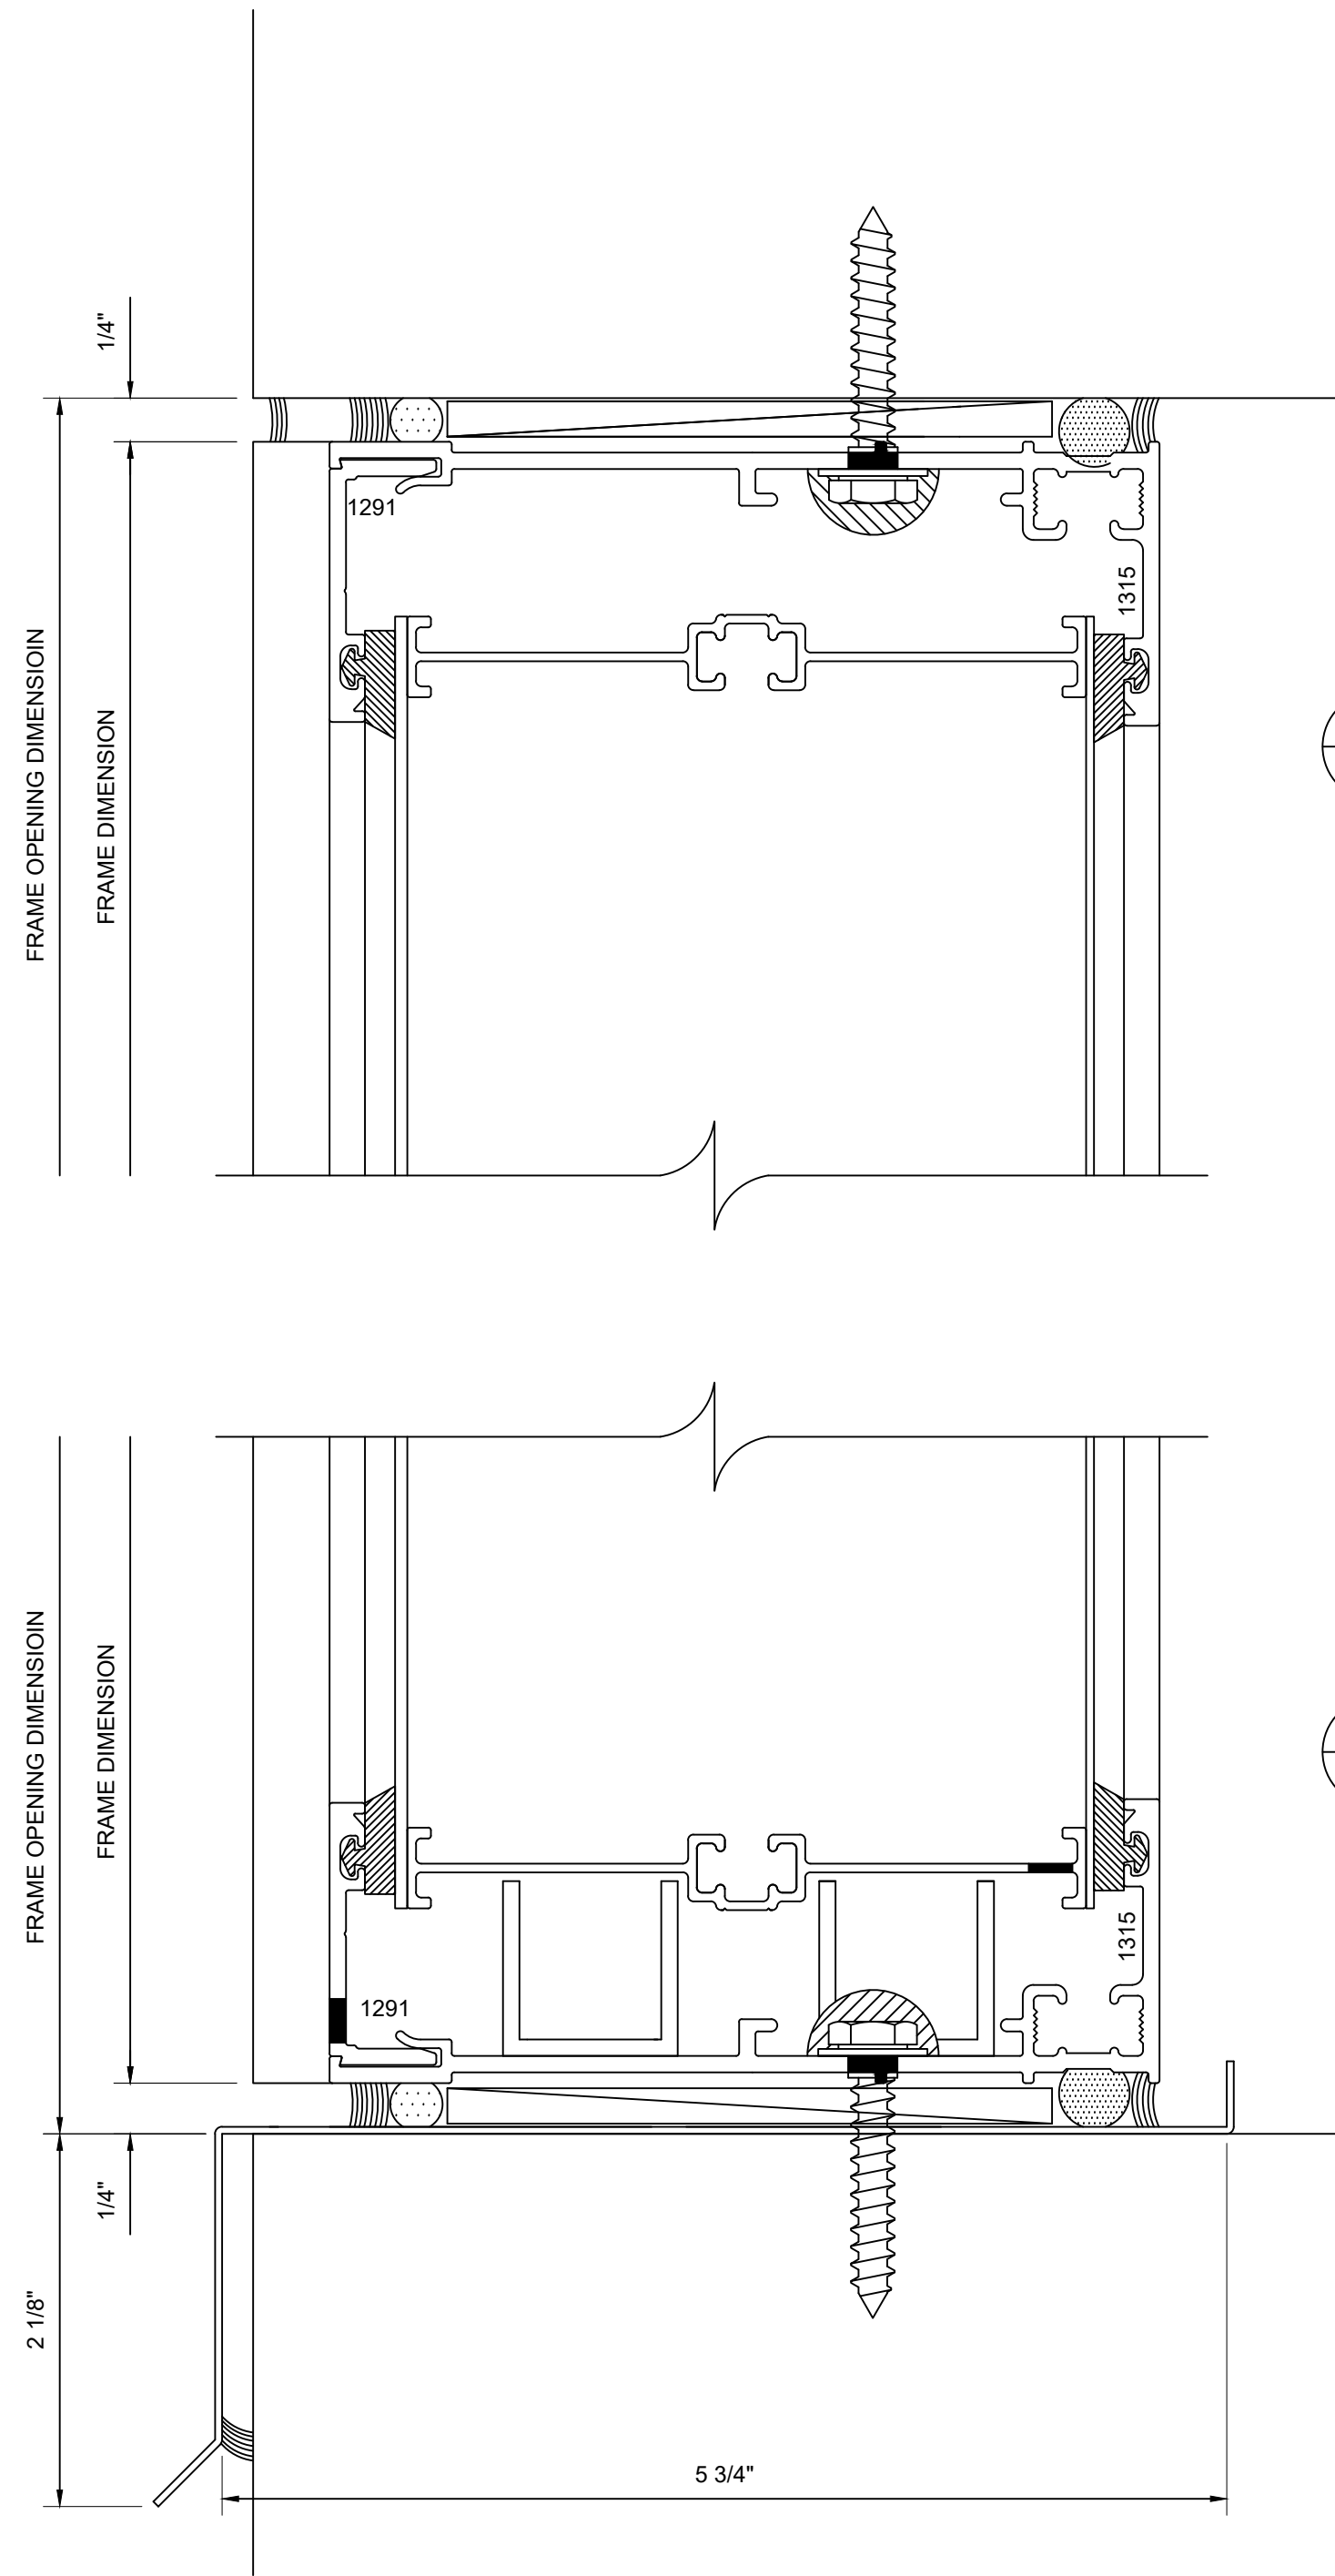
1 2  
- -  
**HEAD DETAIL**  
SCALE: FULL

2 2  
- -  
**SILL DETAIL**  
SCALE: FULL

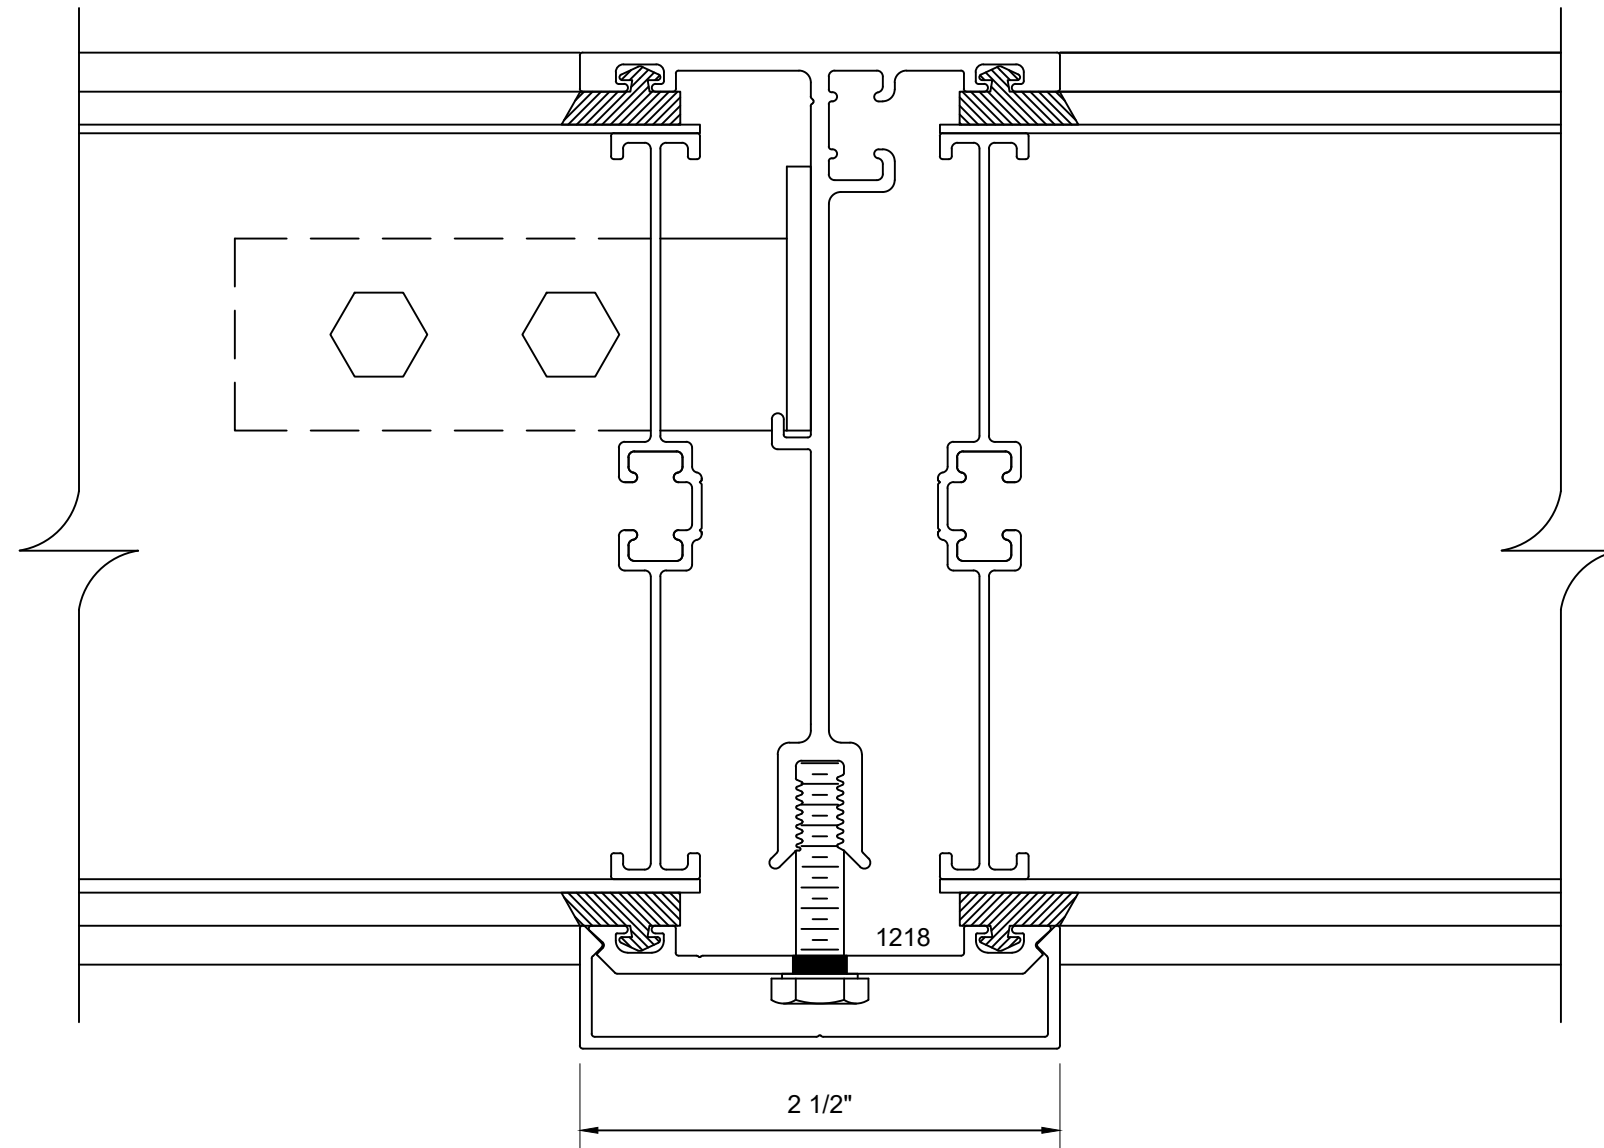
3 2  
- -  
**MULLION DETAIL**  
SCALE: FULL

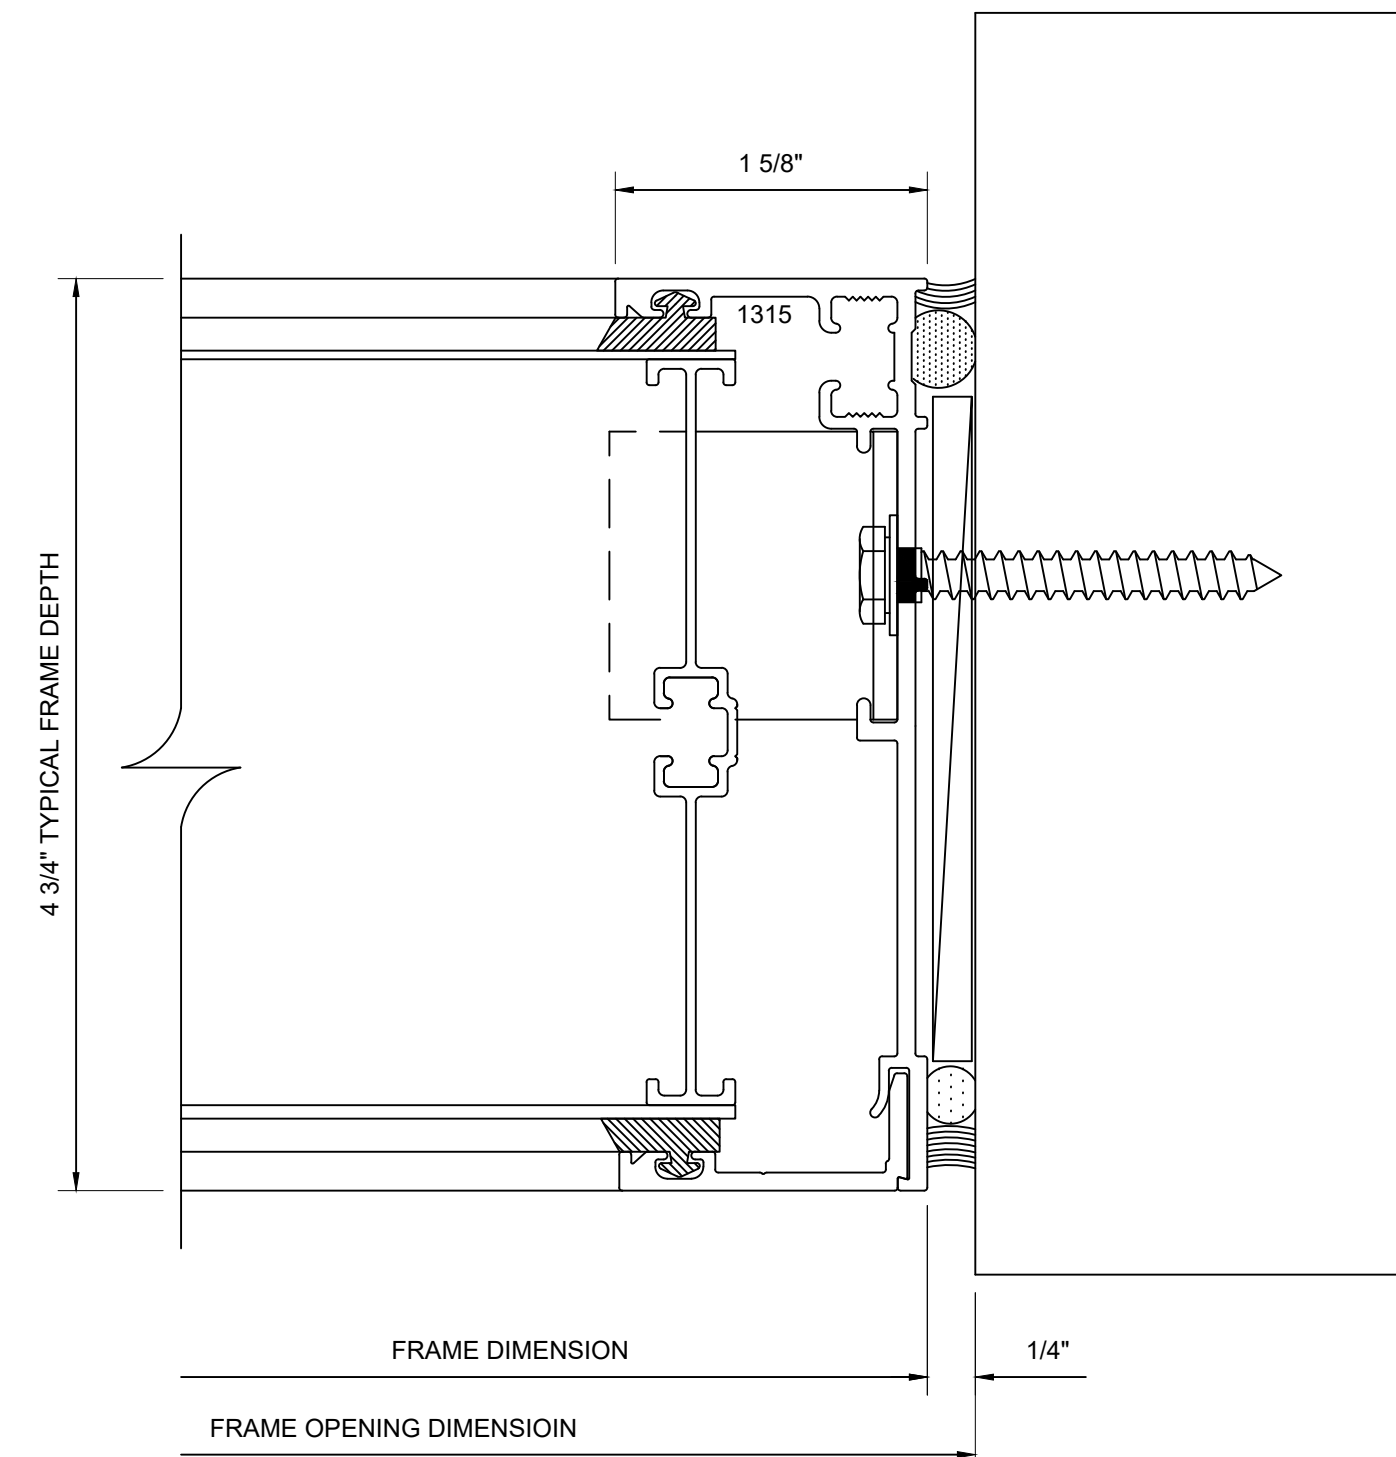
4 2  
- -  
**JAMB DETAIL**  
SCALE: FULL
